**Solid Fuel (Wood) Fire Kitchen with ESP – Washington, D.C.**

FCS19-1002

October 24, 2019

**Location: Rosewood Hotel, Washington, D.C.****Background:**

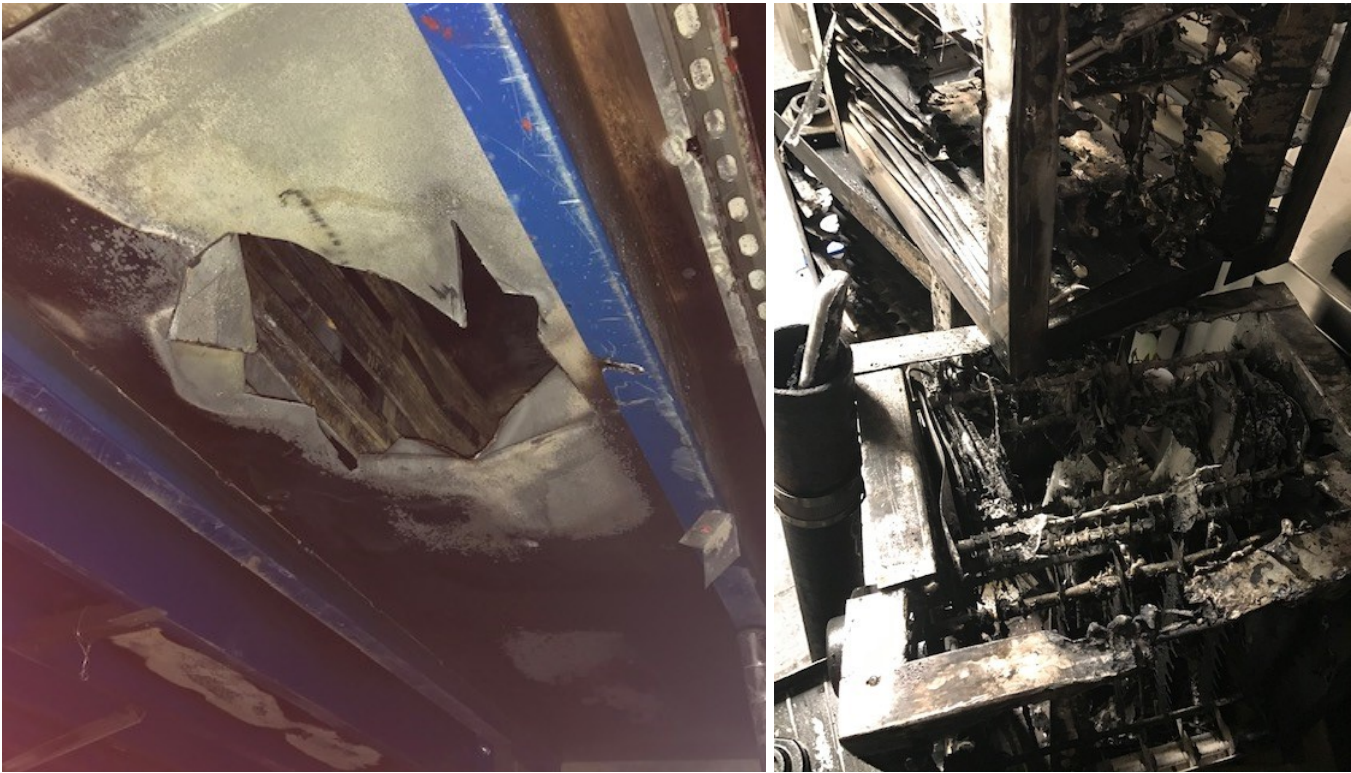
- A high-risk cooking process involving solid fuel appliances. This process produces a high volume of grease and creosote in exhaust ducts.
- Complicated duct including horizontal runs, turns near the ESP, and field welding.
- ESP air cleaning that produces sparks creates a fire hazard due to the accumulation of creosote which has a very low flashpoint and burning point.
- Inadequate wash down controls and fire suppression systems in the duct and ESP units. It is unclear if the washdown system of the ESP unit was working properly.
- The fire originated in the ESP.
- The fixed agent fire suppression system discharged but did not extinguish the fire.

- DC Fire and EMS reported the incident took approximately an hour and a half to get the situation under control.
- A spokesman from the Fire Department labeled this incident as a “labor-intensive process” which puts a strain on the fire department and related emergency service resources.
- The fire caused significant damage to the kitchen exhaust ductwork and ESP unit. For the Fire Department to completely extinguish the fire, the grease duct was cut so that handlines could be advanced through the opening to properly suppress the fire and cool the ESP units.
- The ESP cells were destroyed by the extreme heat of the fire.
- The restaurant is closed indefinitely.

Shown above: Fire department access holes made in the ESP (left) and damaged ESP cells (right).

- Solid fuel, creosote, and superheated grease are major fire hazards. These applications require properly sized self-cleaning hoods, modern CORE Fire Suppression solutions, and factory-built double wall listed duct (non-welded).
- Electrostatic Precipitators should NOT be used for solid-fuel applications.
- CORE Fire Protection with unlimited water from the fire sprinkler system should be installed in the pollution control units to adequately defend against future fires.
- Downstream duct fire detection and suppression should be utilized to detect and eliminate fires that originate in the duct.
- Legitimate preventive maintenance (PM) contracts with a reliable service company must be in place to ensure proper system operation and maintenance.
