**Solid Fuel (Wood) Fire Kitchen – Charlotte, NC**

FCS19-1001

October 9, 2019

**Location: One Bank of America Plaza, Bank of America Tower, Charlotte, NC****Background:**

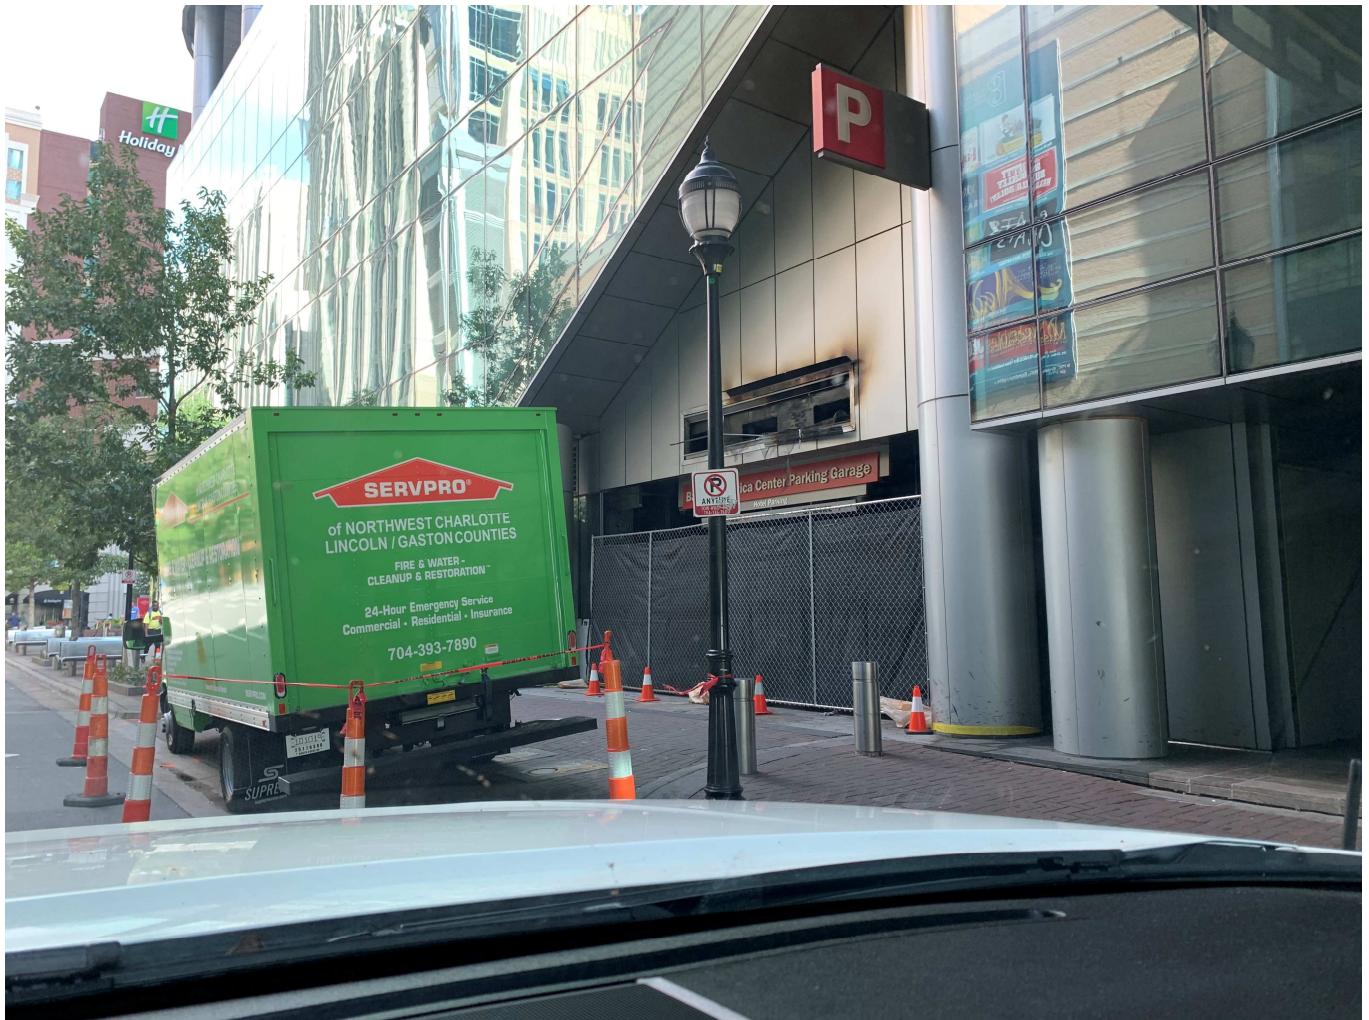
**Photos:**

The Fire Department responded to a fire at 2:42pm on Monday, September 30<sup>th</sup> at a solid fuel wood fire kitchen at the 100 block of College Street, Bank of America Tower, Charlotte NC. The fire started on the second floor of the building and quickly became a 3-alarm fire involving 65 firefighters.

This restaurant uses a high risk, solid fuel, wood rotisserie and wood pizza oven cooking process. The facility has field welded, black iron grease ductwork which traverses multiple floors and has numerous horizontal runs.

- High risk cooking process involving solid fuel, wood rotisserie and pizza oven. This process produces a high volume of grease and creosote in exhaust ducts.
- Complicated duct runs exist at this facility, including long horizontal runs, low spots in the duct, and pollution control units.
- Low points are present in the grease duct; some are inaccessible for proper cleaning. This allowed fuel to build up in the duct.
- Inadequate fire suppression system in the hood and pollution control system. The system discharged but did not extinguish the fire.
- The hood/duct cleaning company was onsite the day before the fire, but due to inadequate cleaning, the fuel sources were not adequately removed.

- Solid fuel cooking appliances should be replaced by conventional non-solid fuel cooking appliances.
- Solid fuel, creosote and superheated grease are major fire hazards. They require modern hood, duct and fire suppression solutions.

- Proper hood, fire system and duct design are required for high risk, solid fuel applications.
- New listed duct must be installed to properly contain future fires.

- CORE Fire Protection with unlimited water from the fire sprinkler system should be installed in the hood and pollution control units to adequately defend against future fires.

- Self-cleaning hoods with a daily wash cycle should be used to minimize duct fuel load.
- Downstream duct fire detection and suppression should be utilized to detect and eliminate fires that originate in the duct, downstream of the hood.

- Legitimate preventive maintenance (PM) contracts with a reliable service company must be in place to ensure proper system operation and maintenance.
